SIM 61 05 23

## RECALL 23V-337: FOOTWELL MODULE (FRM) MOISTURE/WATER INTRUSION

This Service Information Bulletin (Revision 5) replaces SI B61 05 23 **dated October 2024**.

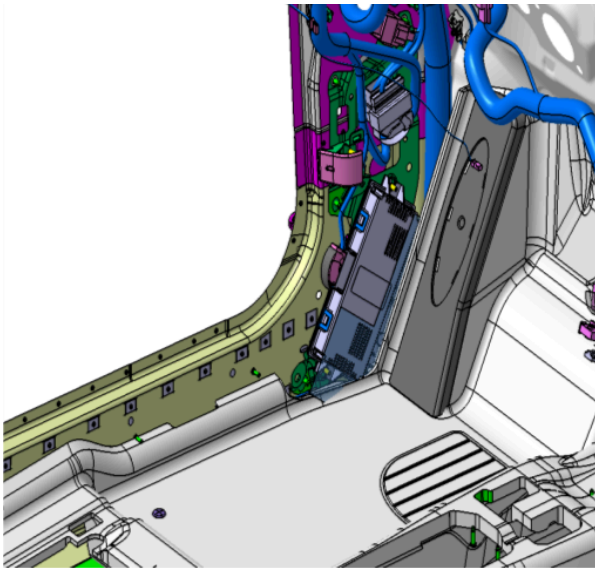
9. Inspect the driver and passenger side floorboard for any corrosion/oxidation.

If the floorboard on either side has any corrosion/oxidation on it, it will need to be removed using a wire brush and then primed using 2K epoxy primer to protect it against corrosion.
